## Right Wing Gear Assembly

Log Number      LG5  
Debris Field    Green  
Target Number   C1033  
Coordinates:  
    Latitude      \_\_\_\_\_  
    Longitude     \_\_\_\_\_

RIGHT WING GEAR  
GREEN TAG C-1033  
IPC 32-11-01-01,  
FIG 1, SHEET 1

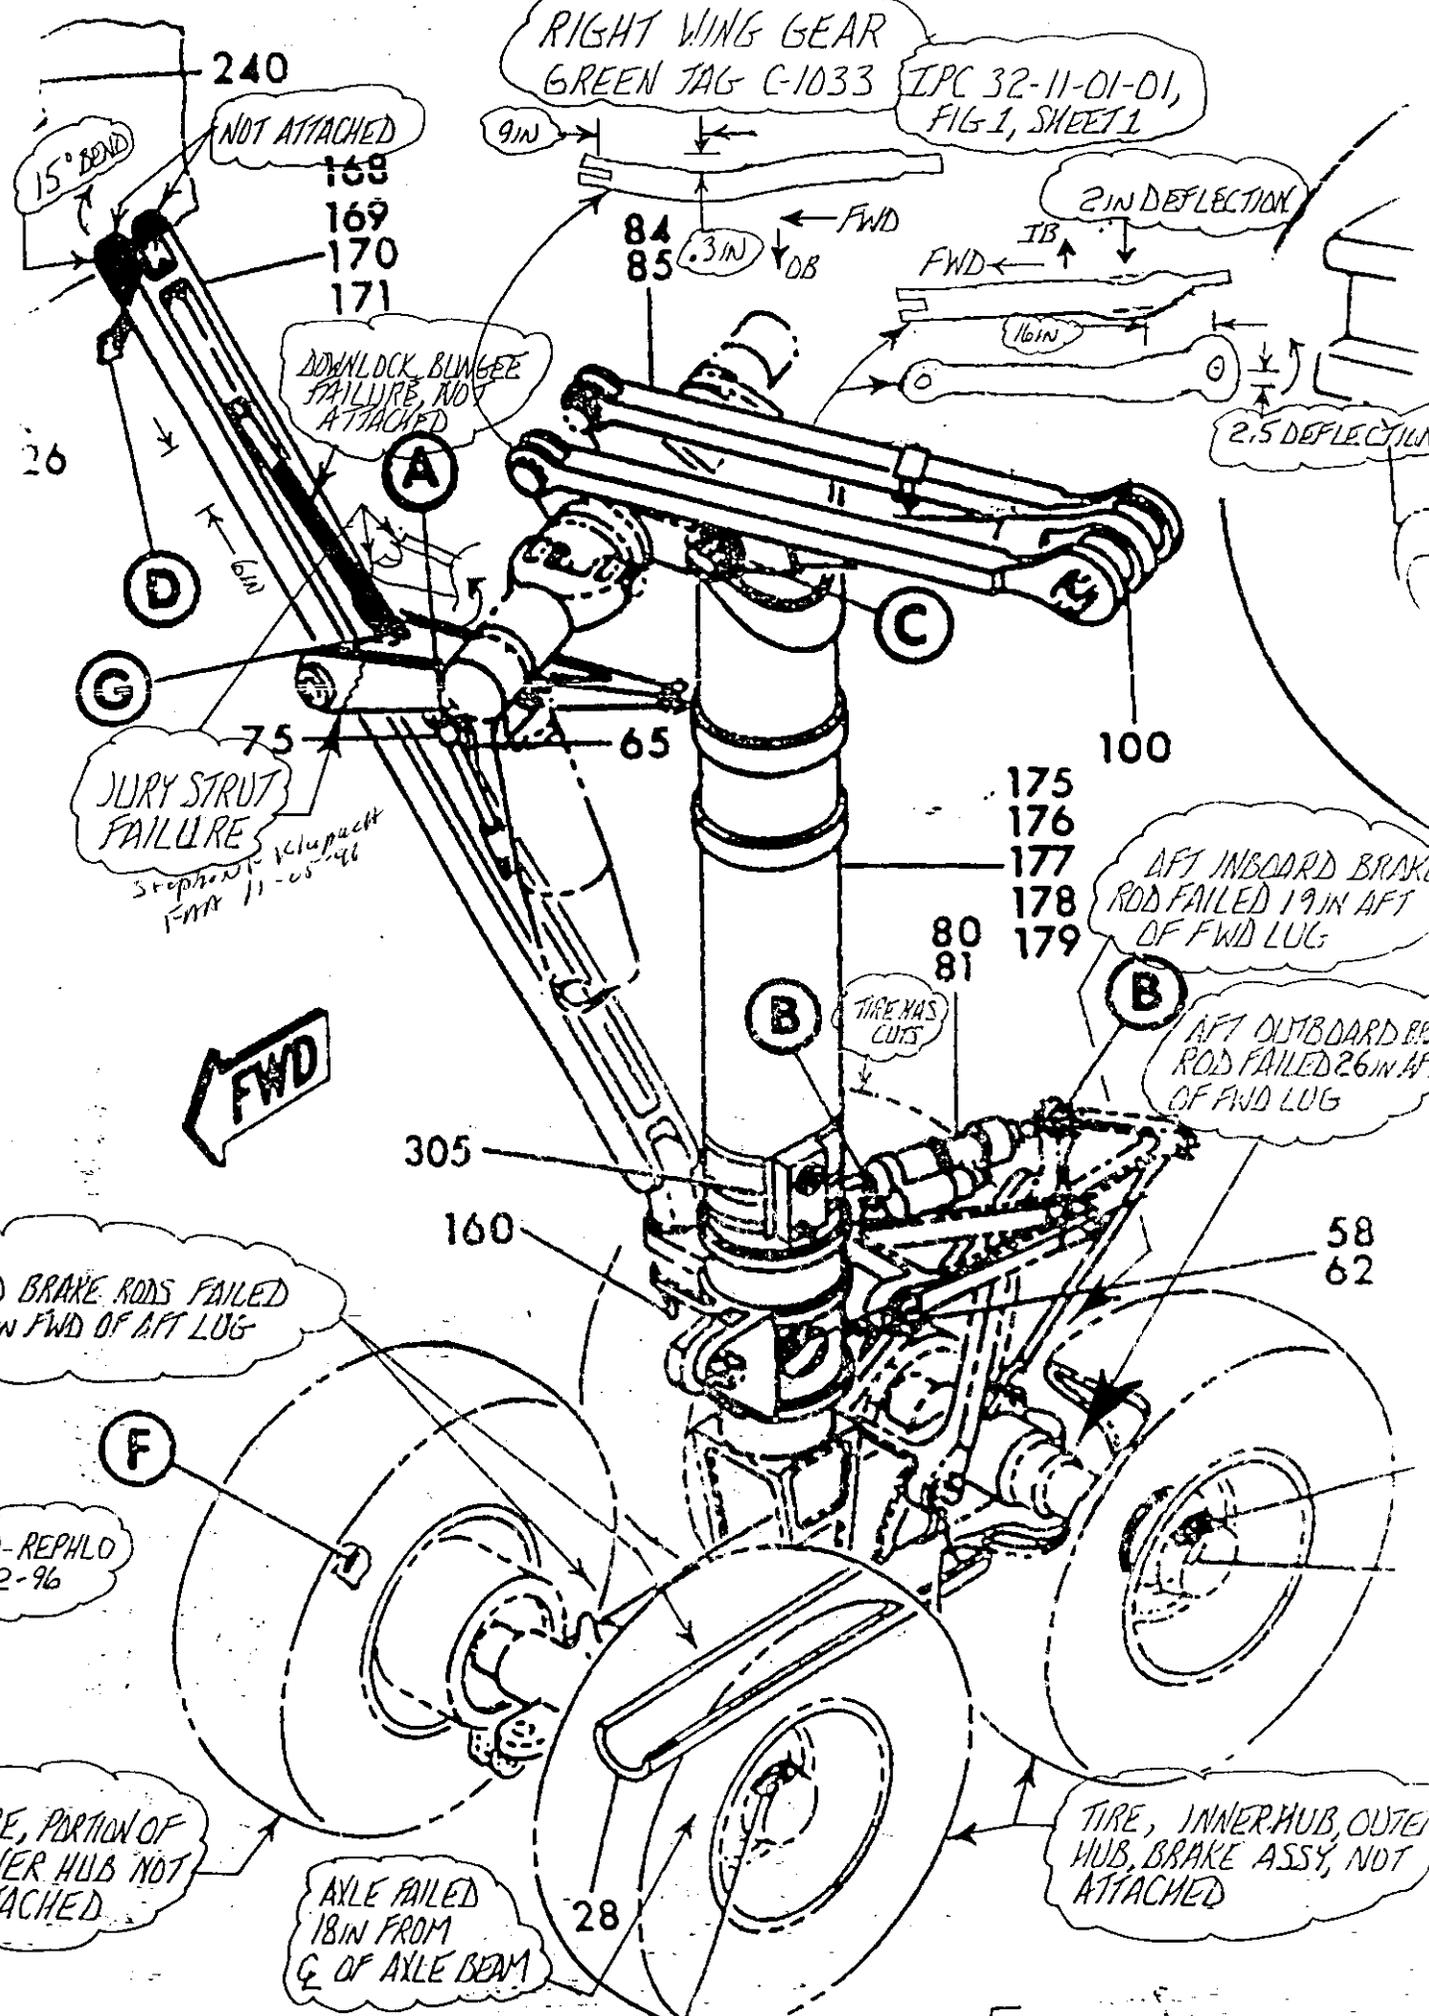
Right wing gear assembly is not attached to trunnion fittings.

Some hydraulic lines remain attached.

Some wiring remains attached.

Downlock bungee failed approximately six inches below upper attach point.

Jury strut became unattached to outer cylinder but remained attached to the downlock actuator. Jury strut failed at side strut joint as shown on illustration.

All brake rods failed as shown on illustration.

Forward outboard axle failed eighteen inches from gear beam centerline.

Retract stabilizing arms were bent as shown on illustration.

Outboard tires, inner hubs, outer hubs, and brake pads not attached to gear assembly. Forward inboard outer hub failed allowing tire to depart gear assembly. Aft inboard tire has cuts.

General scratching through paint layer only. No visible signs of soot.

NOT ATTACHED

15° BEND

DOWNLOCK BUNGEE  
FAILURE, NOT  
ATTACHED

JURY STRUT  
FAILURE

FWD BRAKE RODS FAILED  
20 IN FWD OF AFT LUG

TIRE, PORTION OF  
INNER HUB NOT  
ATTACHED

AXLE FAILED  
18 IN FROM  
C OF AXLE BEAM

TIRE, INNER HUB, OUTER  
HUB, BRAKE ASSY, NOT  
ATTACHED

2 IN DEFLECTION

2.5 DEFLECTION

AFT INBOARD BRAKE  
ROD FAILED 19 IN AFT  
OF FWD LUG

AFT OUTBOARD BRAKE  
ROD FAILED 26 IN AFT  
OF FWD LUG

TIRE HAS  
CUTS
